Test carried out by Stephen Fish & Florian Sicleanu  
Thursday 11th April 2024

Water ingress to windows below balcony.

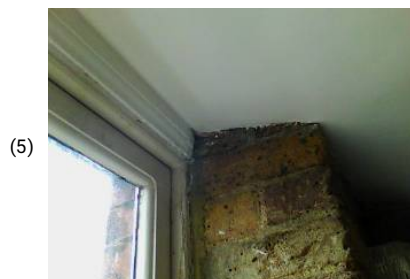
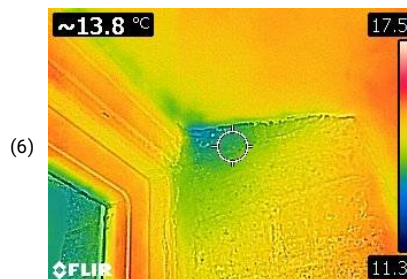
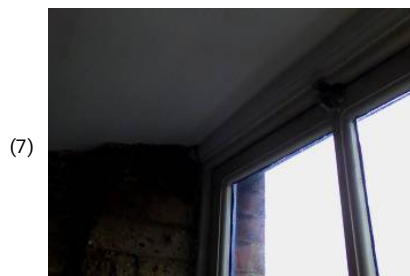
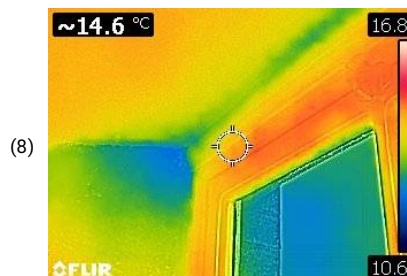
Thermal imaging revealed cold spots either side of window and above centre point.

Cold spots were checked with a small damp meter and did show elevated moisture levels in brickwork, ceiling and architrave. No more than 50mm to 75mm from frame.

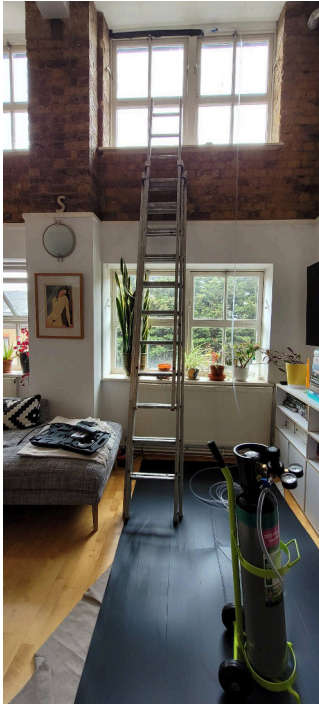
(17)

From visual evidence provided by the residents, the water collects on the underside of the top rail of the frame. Since the ceiling slopes down from the window, the water is collecting immediately on top of the frame and seeping through between the frame and the architrave. Not penetrating the inner wall and hitting the ceiling.

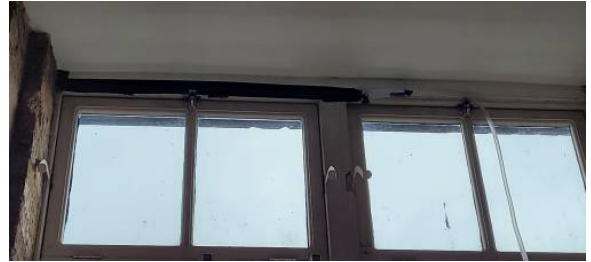
(18)

Pipe punctured every 6" and taped under gap.

Trace gas test rig 1

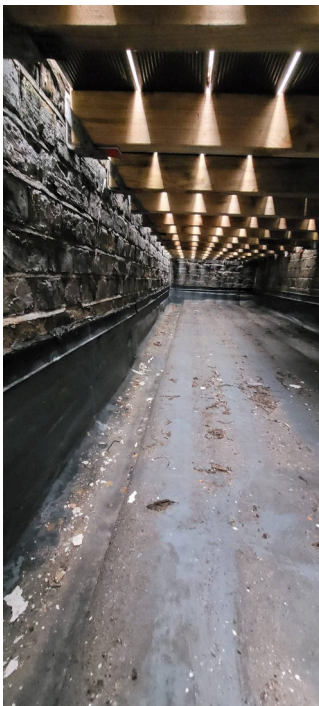
(19)

Area under decking on balcony, above window

Outlet was clear of debris

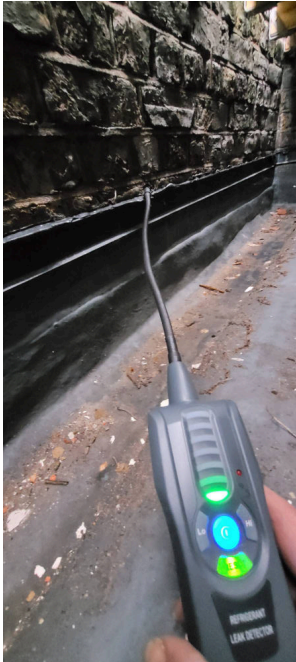
(21)

No trace of gas from termination or brickwork under decking.

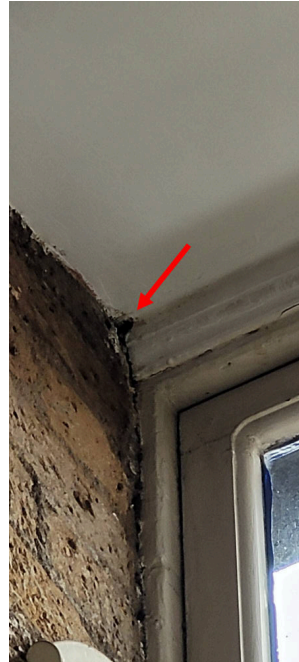
(22)

Test rig 2a involved inserting gas pipe in small hole in corner, positive reading on exterior brickwork.

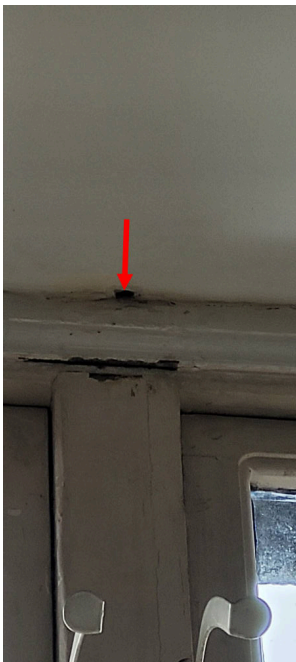
(23)

Test rig 2b pipe inserted in hole at centre, again positive readings on exterior brickwork.

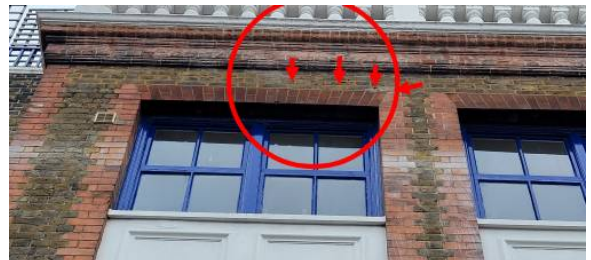
(24)

Pointing immediately above header course gave positive reading in several places.

My recommendation would be to carry out mortar repairs and apply a general brickwork waterproofing system to the wall between the balustrade and the windows. This may be possible by abseiling or a scaffold platform.

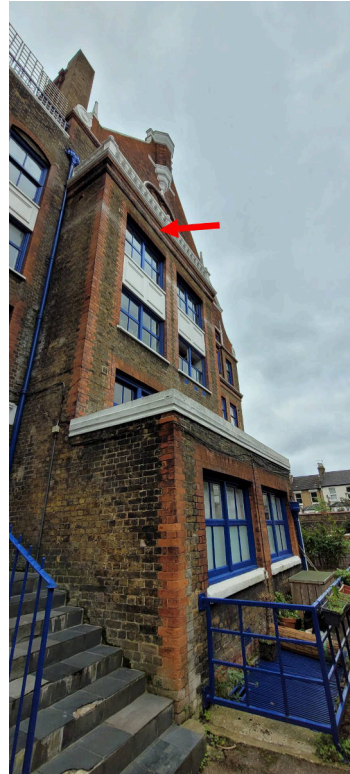
(26)

Protruding building at ground level has glass roof so simple access tower is not possible, approximate height of header is 8m.
