Test carried out by Stephen Fish & Florian Sicleanu  
Thursday 11th April 2024

Water ingress to windows below balcony.

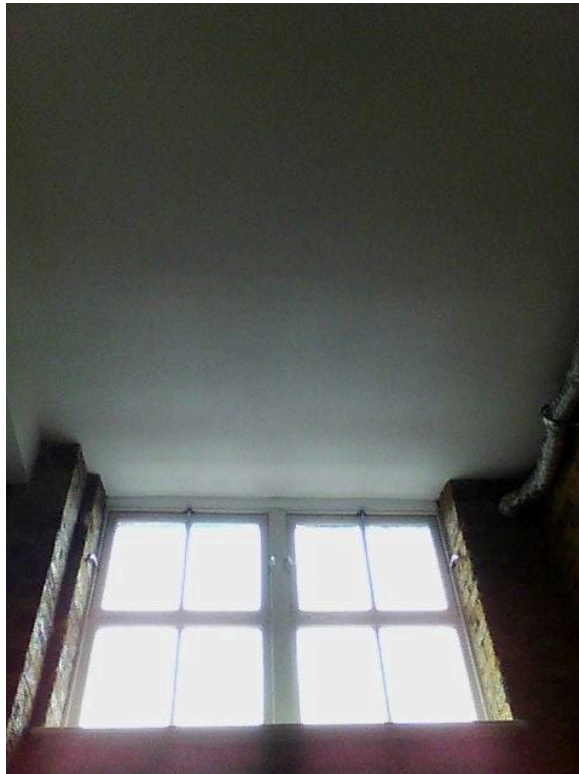
(9)

Cold spots were checked with a small damp meter and did show elevated moisture levels in brickwork, ceiling and architrave. No more than 50mm to 75mm from frame.

My recommendation would be to carry out mortar repairs and apply a general brickwork waterproofing system to the wall between the balustrade and the windows. This may be possible by abseiling or a scaffold platform.

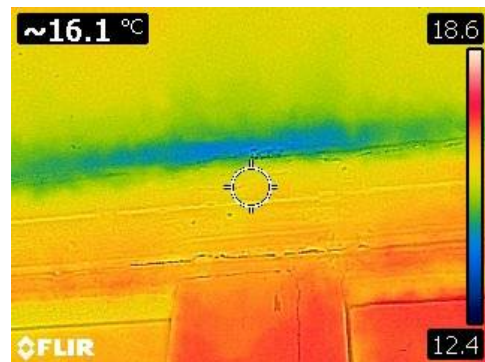
(16)

From visual evidence provided by the residents, the water collects on the underside of the top rail of the frame. Since the ceiling slopes down from the window, the water is collecting immediately on top of the frame and seeping through between the frame and the architrave. Not penetrating the inner wall and hitting the ceiling.
